**STRUCTURAL DESIGN FOR FUEL CONTAINMENT
UNDER SURVIVABLE CRASH CONDITIONS**

General Dynamics | Convair, San Diego, Calif.

138P
FEDERAL AVIATION AGENCY

Technical Report ADS-19

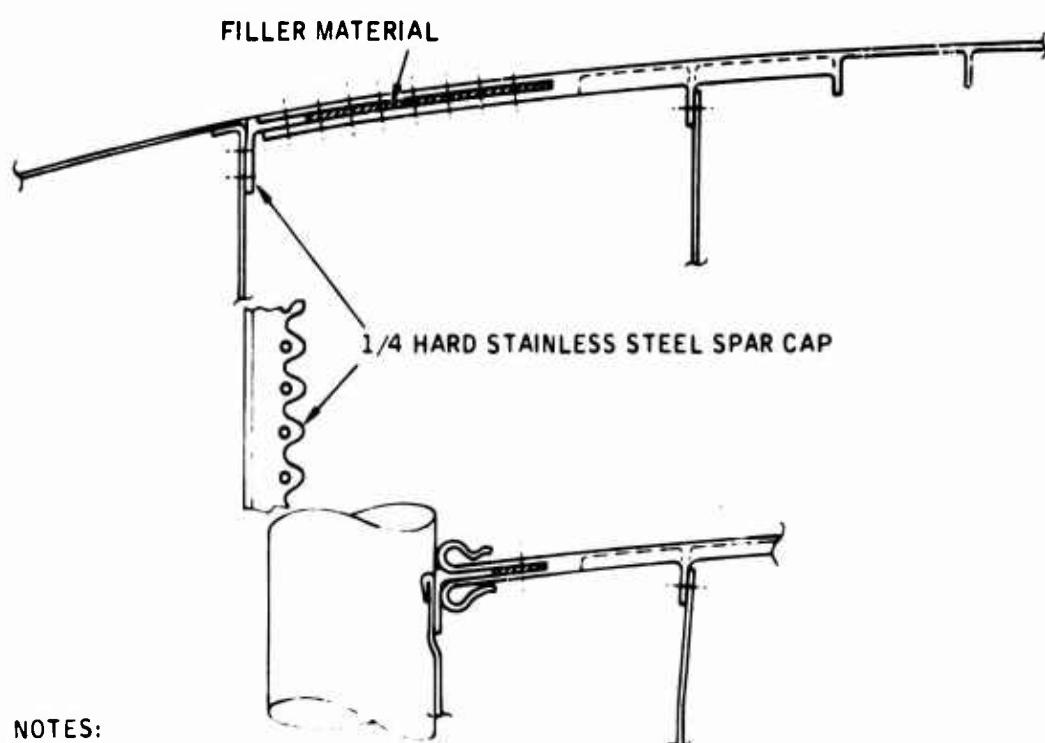
Figure A-23. Energy-Absorbing Structures (E)

This design is restricted to cutting down trees or poles. The added weight cannot increase the basic strength of the wing and, therefore, is dead weight.

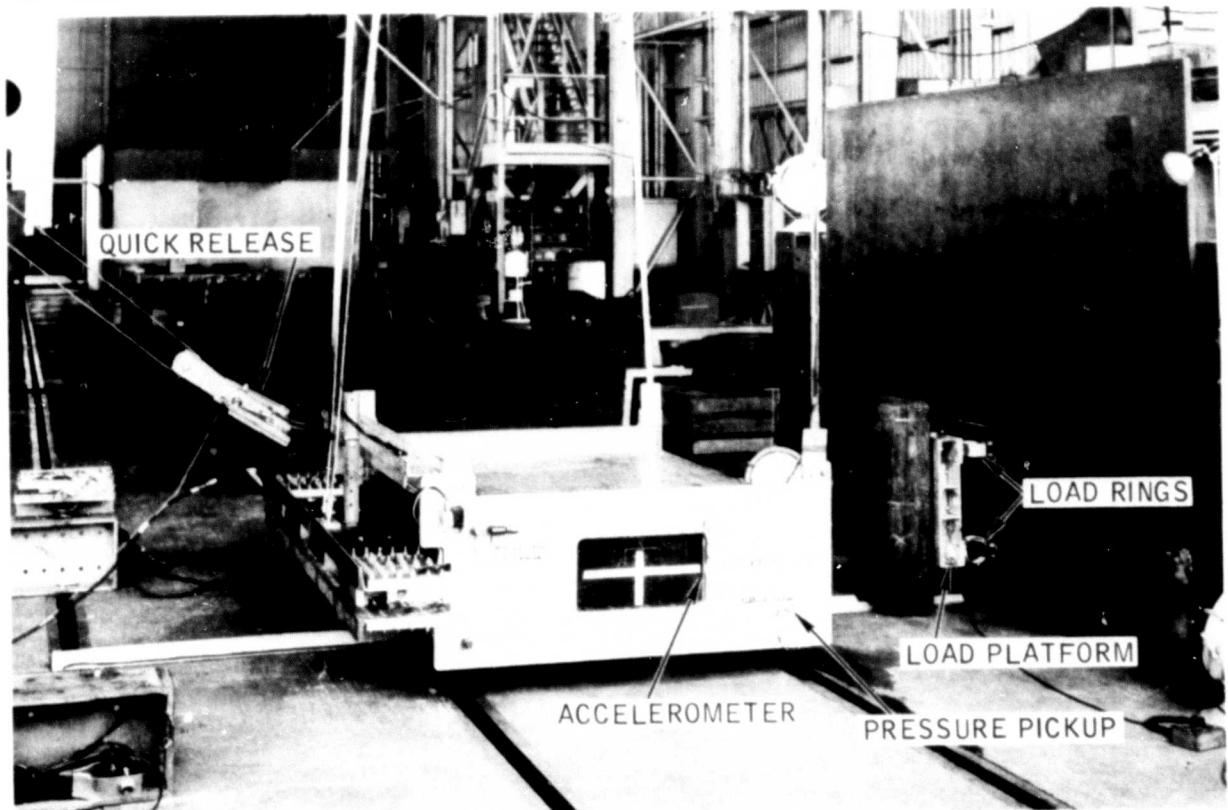
B. 2.4 LOG IMPACT TESTS — In these tests, tank specimens were impacted against sections of a large-diameter telephone pole (Figure B-5) mounted on a strain-gaged platform dynamometer which measured impact load versus time. Other instrumentation recorded tank deceleration and fuel pressure versus time. All specimens except Tank No. 6 were eventually ruptured by this test method.

Figure B-5. Log Impact Arrangement. Note aluminum platform to which log is bolted; calibrated strain rings support platform.

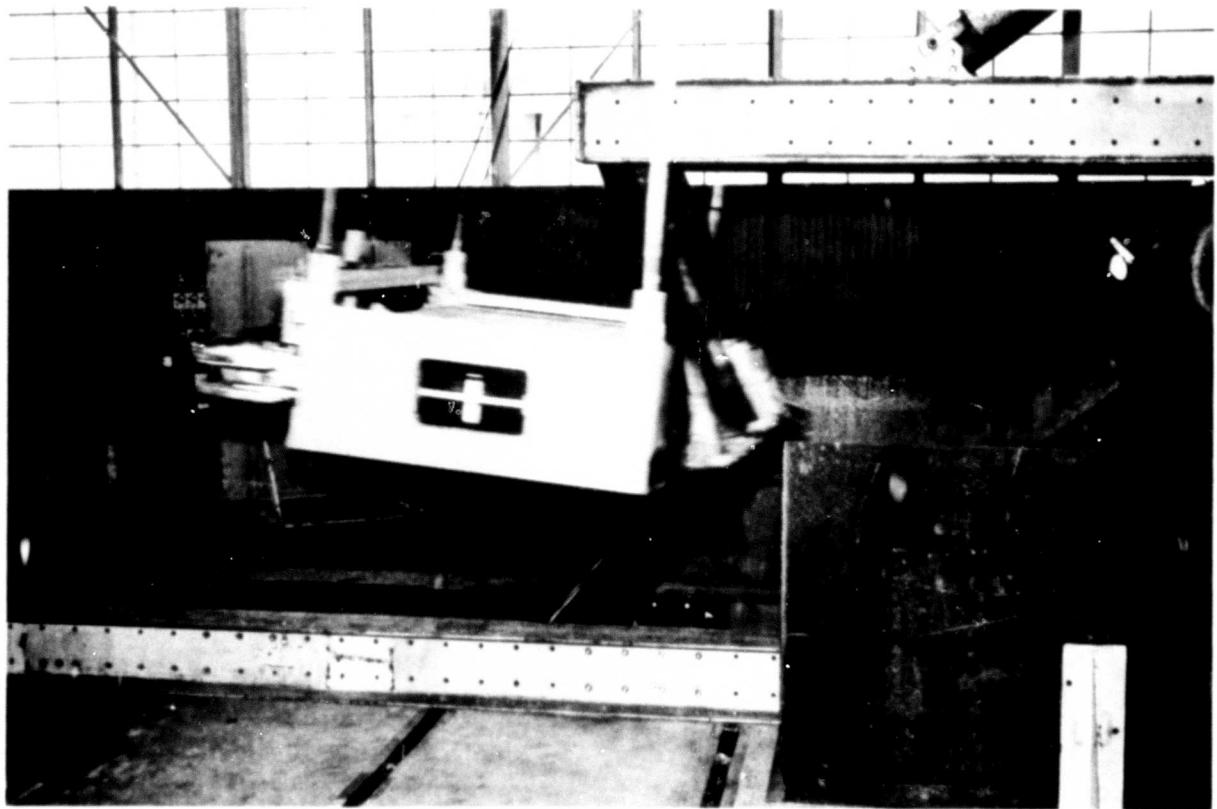
Figure B-6. Pole Breaking Test. Tank specimen breaks an 8-ft. section of pole supported at both ends.

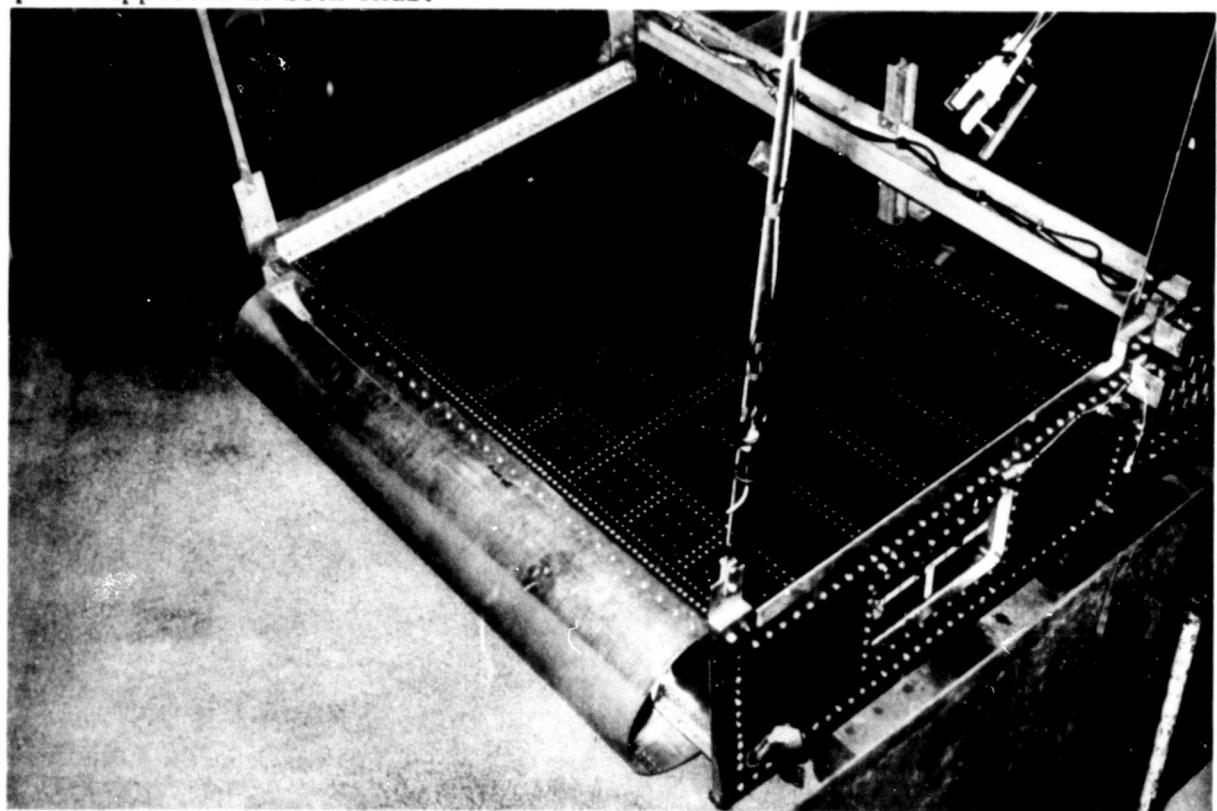
Figure B-7. Distributed Impact. Mound was arranged on a 30-deg. slope; impact against piles of dry and wet sand and sand/rock were compared.

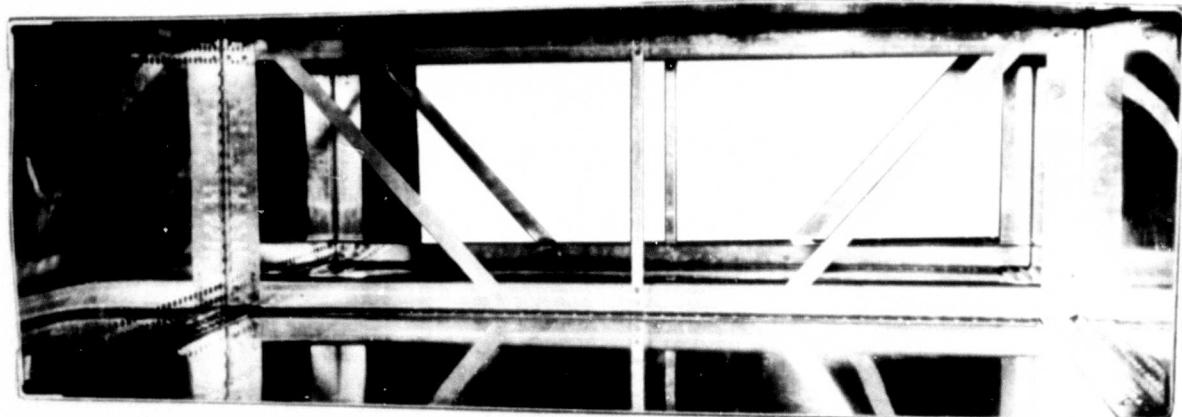
Figure B-10. Test Tank No. 1. This was a light, simple tank specimen measuring 16" x 48" x 72". Filled with water, 48" chord simulated 60" chord fuel filled tank.

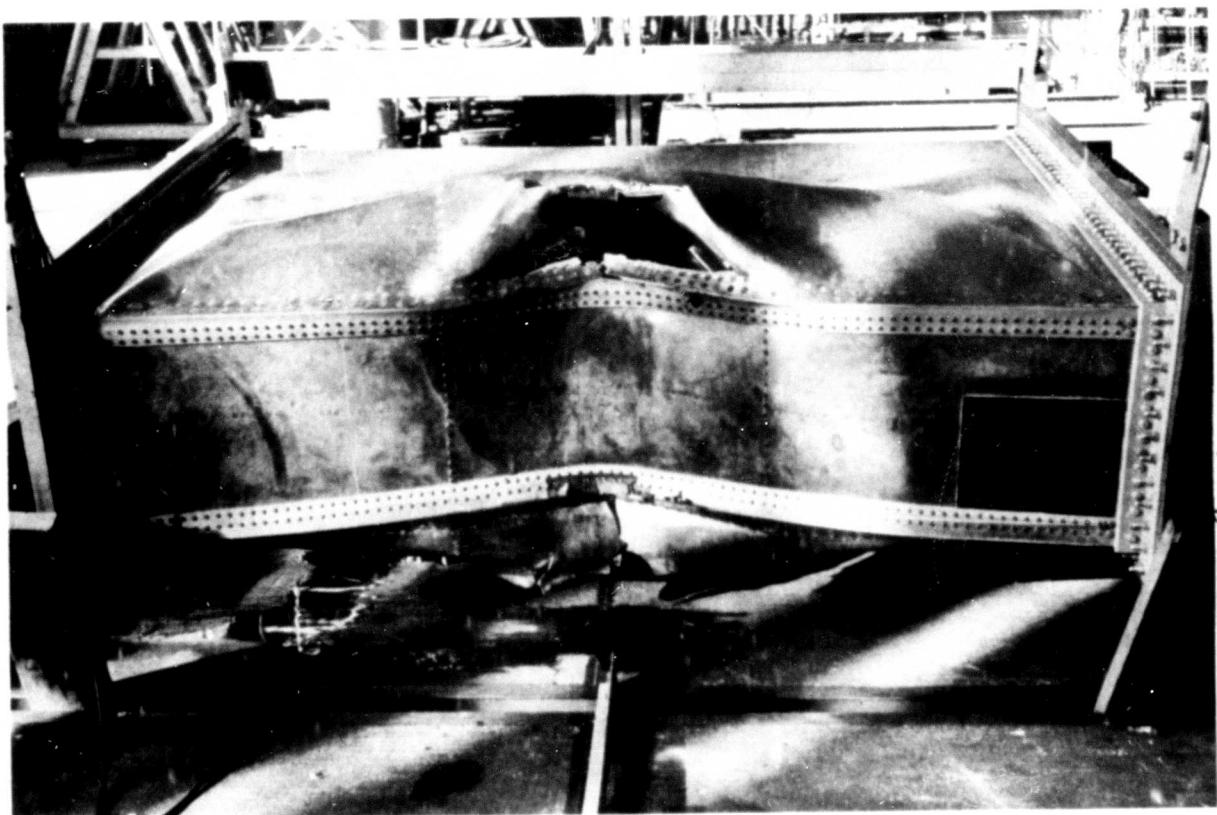
Figure B-12. Failure of No. 1 Test Tank. Result of Drop No. 4 — log impact test, 10-ft. drop height, impact load 34,100 lb.

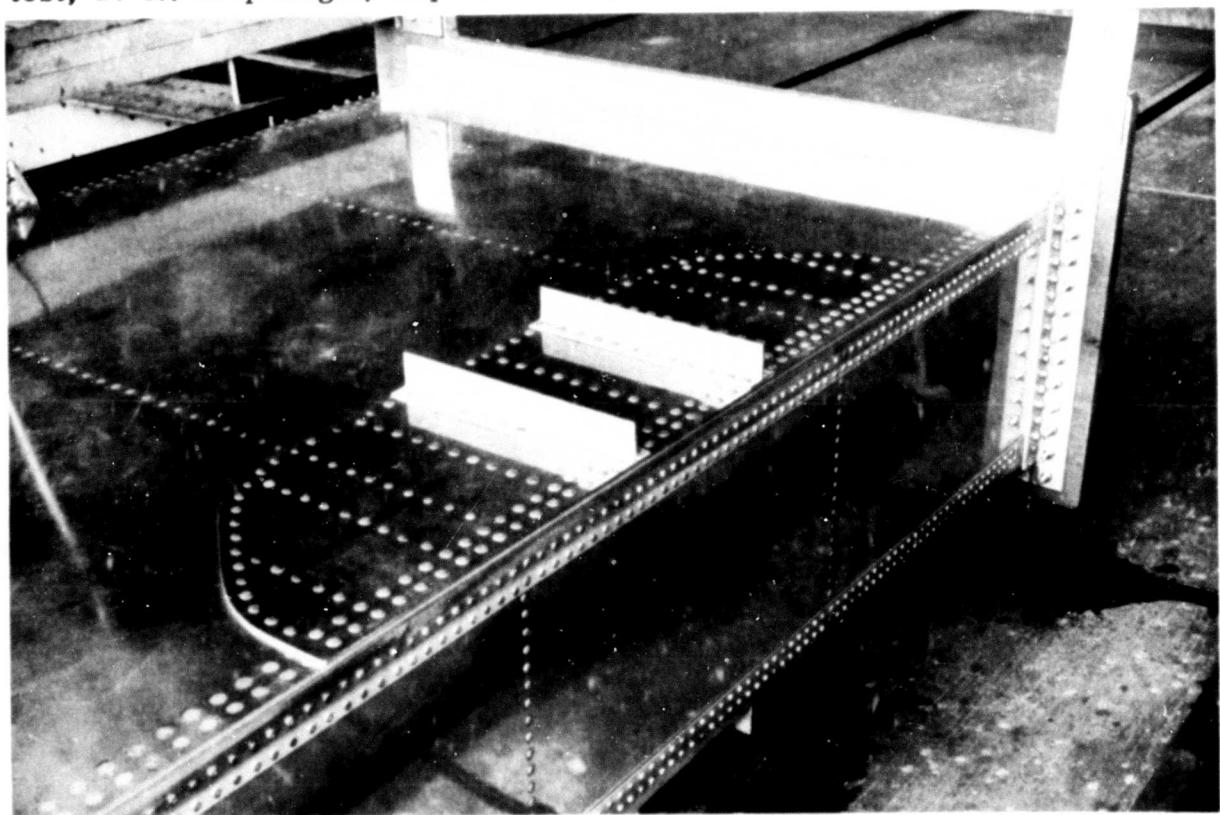
Figure B-13. Test Tank No. 2. Specimen was identical to Tank No. 1 except for skin stiffening on upper and lower surfaces.

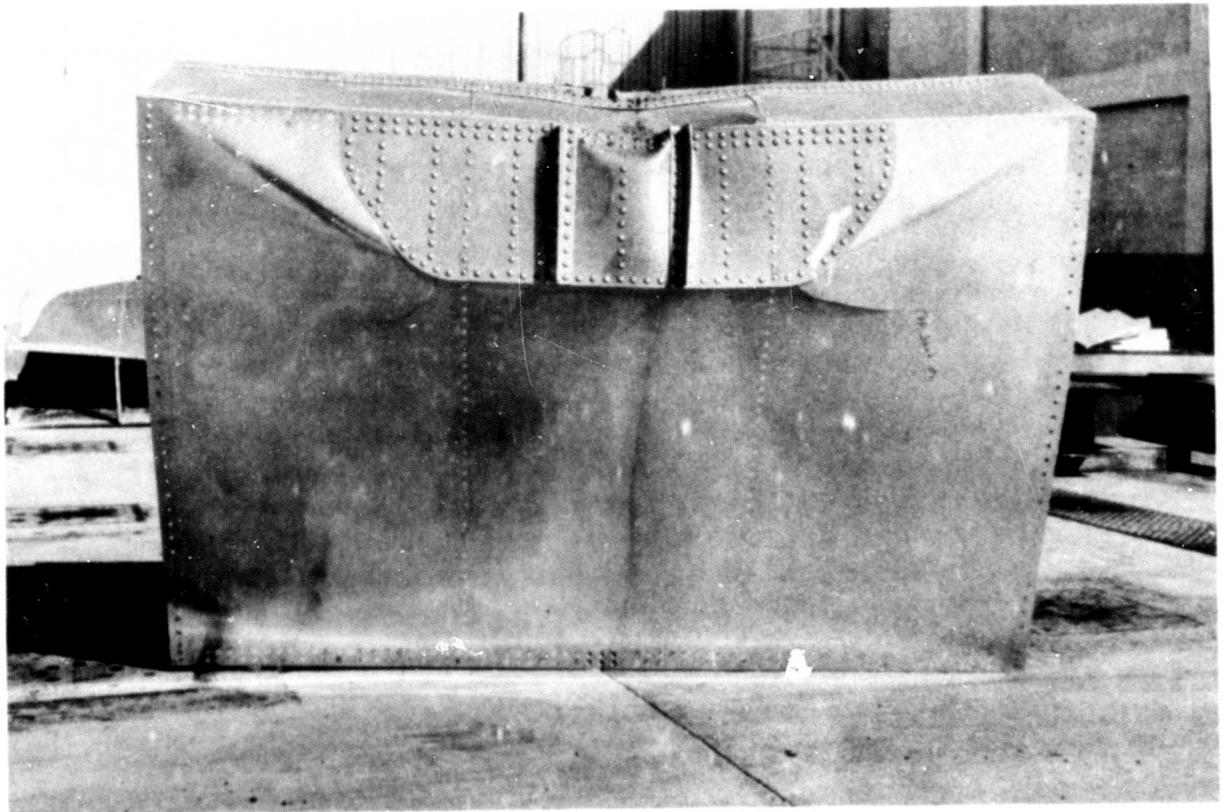
Figure B-14. Failure of Tank No. 2. Failure of upper surface after Drop 10, log impact — 6-ft. drop height, impact load 52,700 lb.

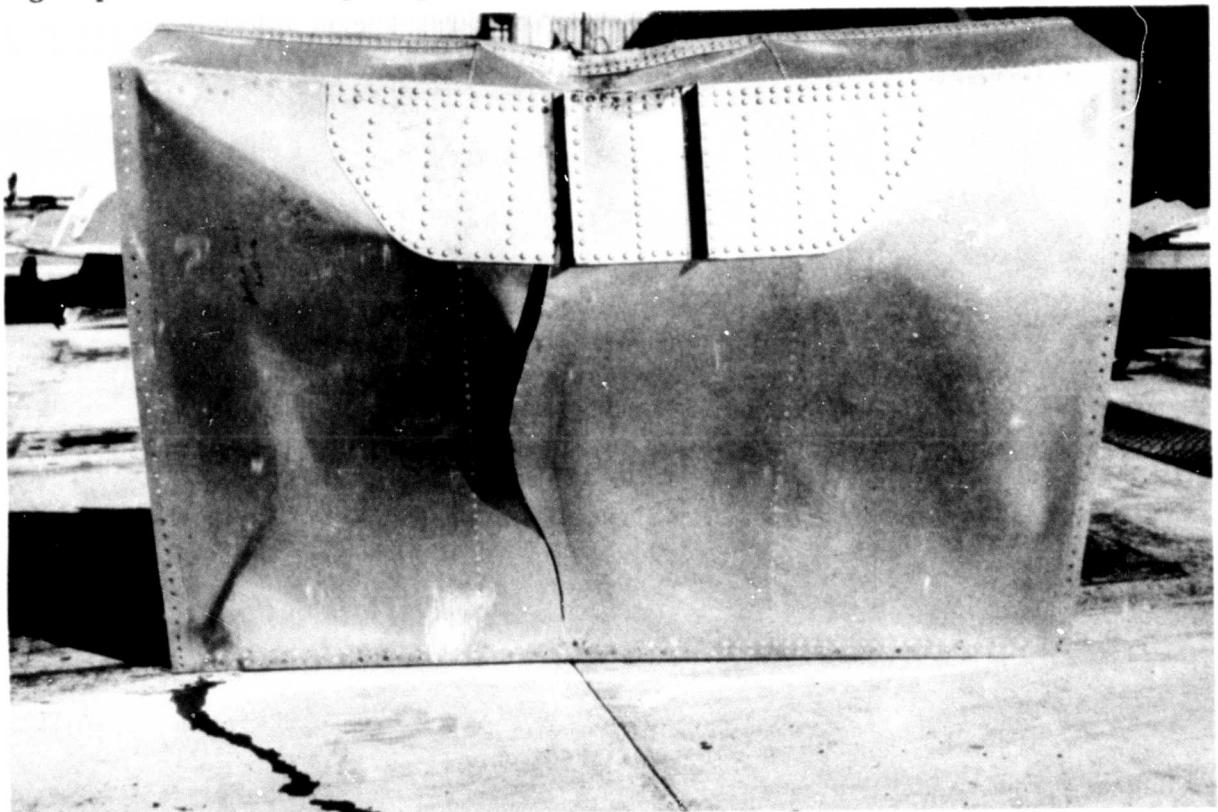
Figure B-15. Failure of Tank No. 2. Lower surface shown; note bending failure of doubler.

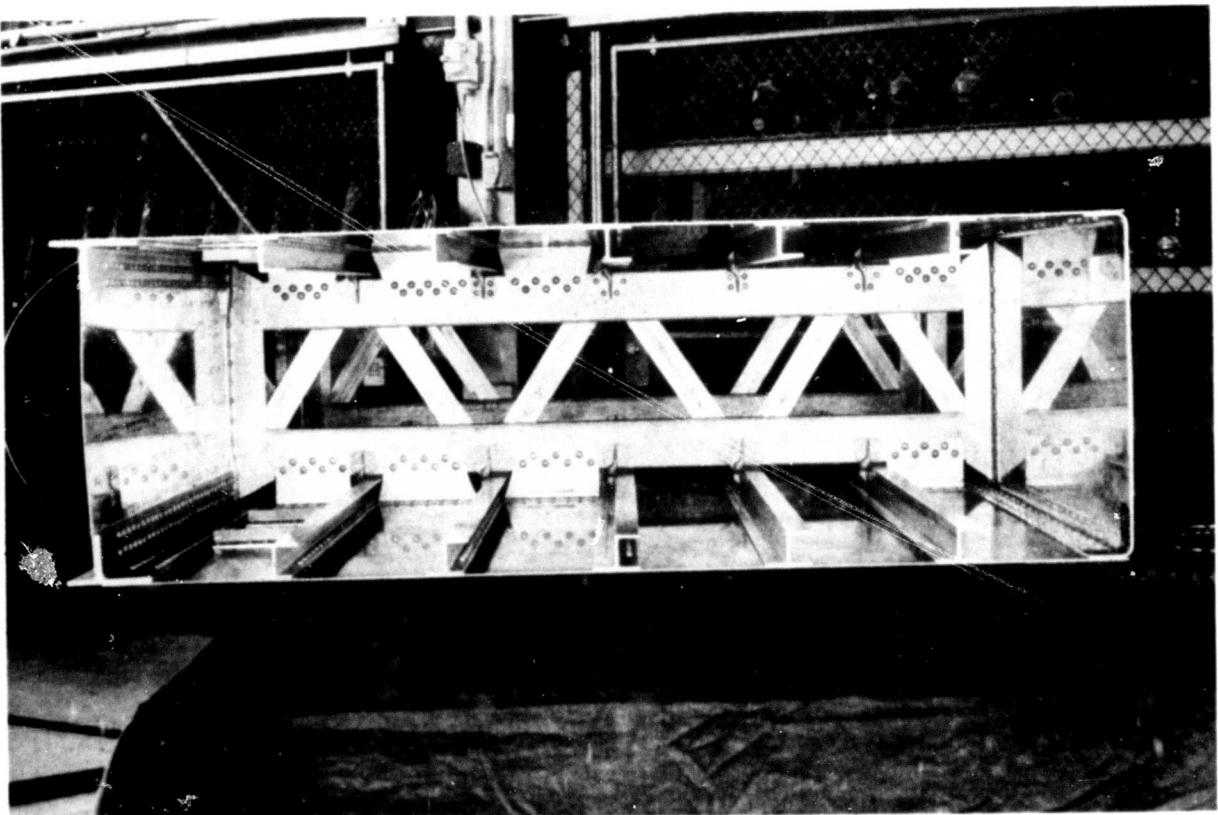
Figure B-16. Test Tank No. 3. Tank structure was similar to wing of existing jet transport.

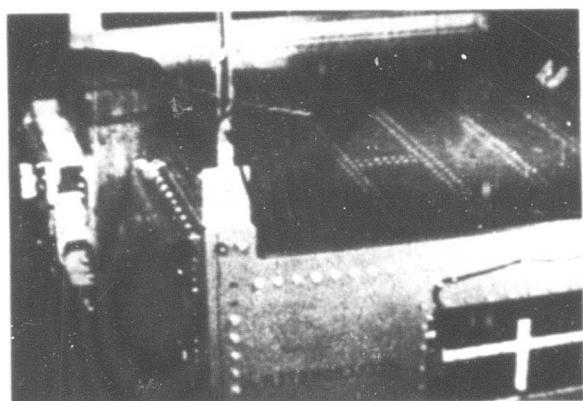
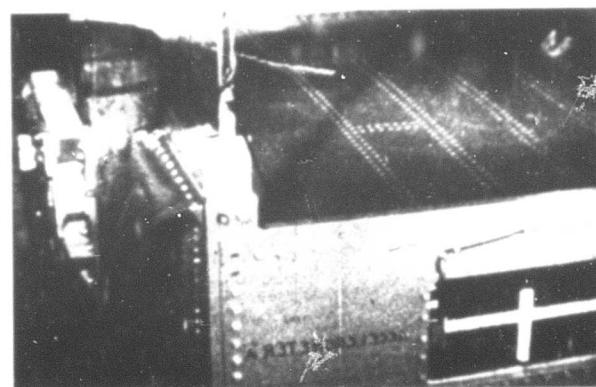
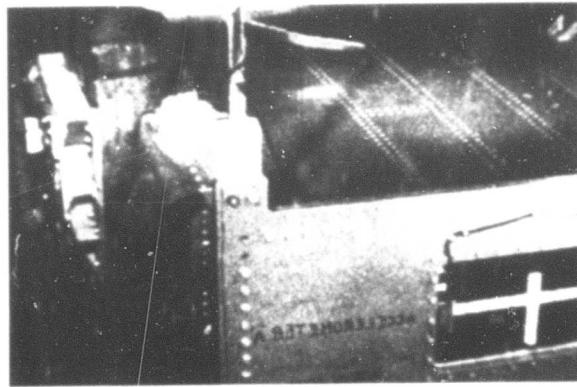
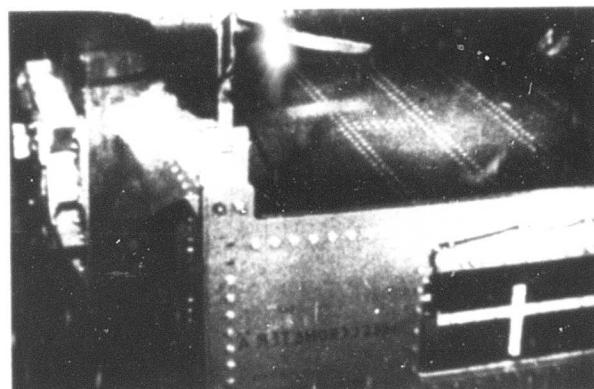
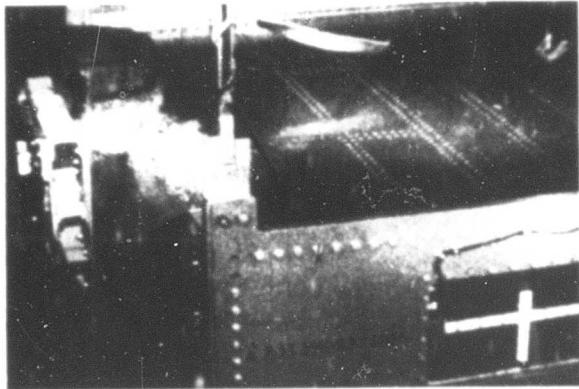
Figure B-17. Drop No. 12. Log impact, Tank No. 3, max. velocity 17.9 fps, peak load 70,070 lb.

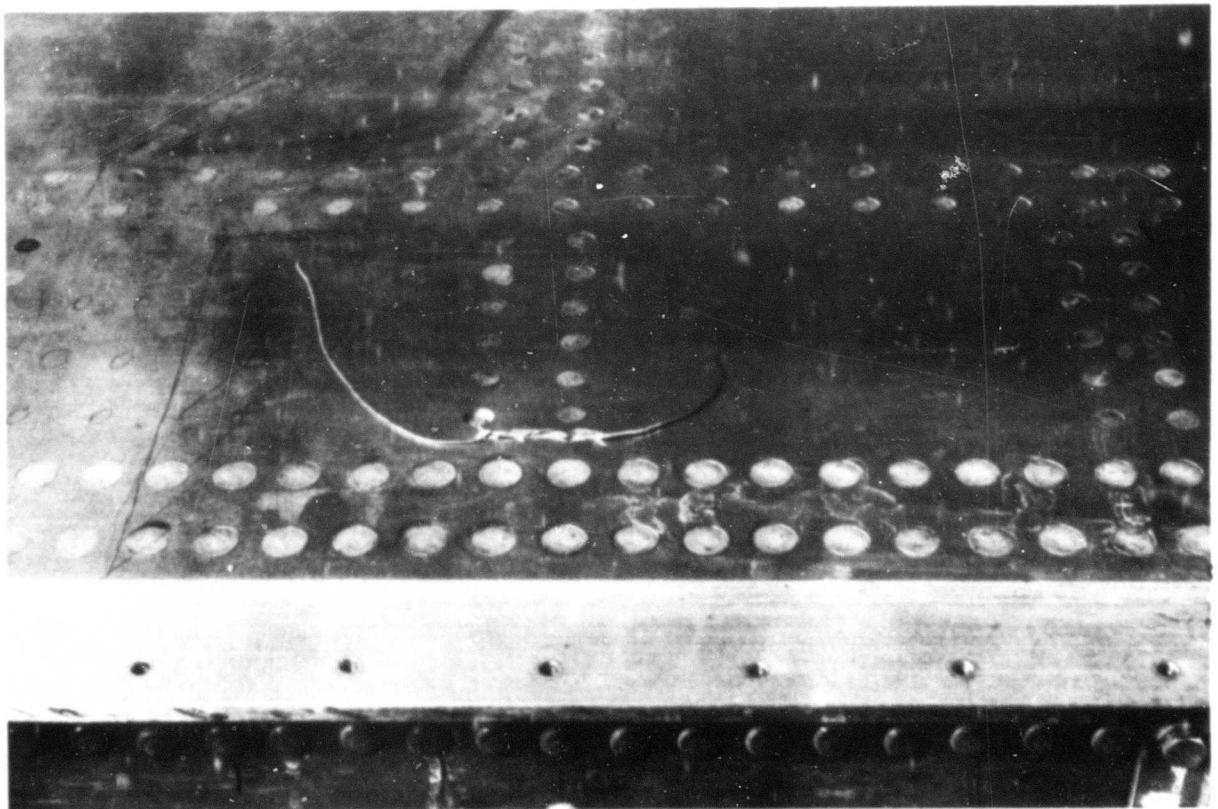
Figure B-18. Failure of Test Tank No. 3. Drop No. 12 upper skin rupture at front spar resulted from log impact test from 5-ft. drop height. Similar fracture appeared at other rib, lower skin did not fail. Impact load was 70,070 lb.

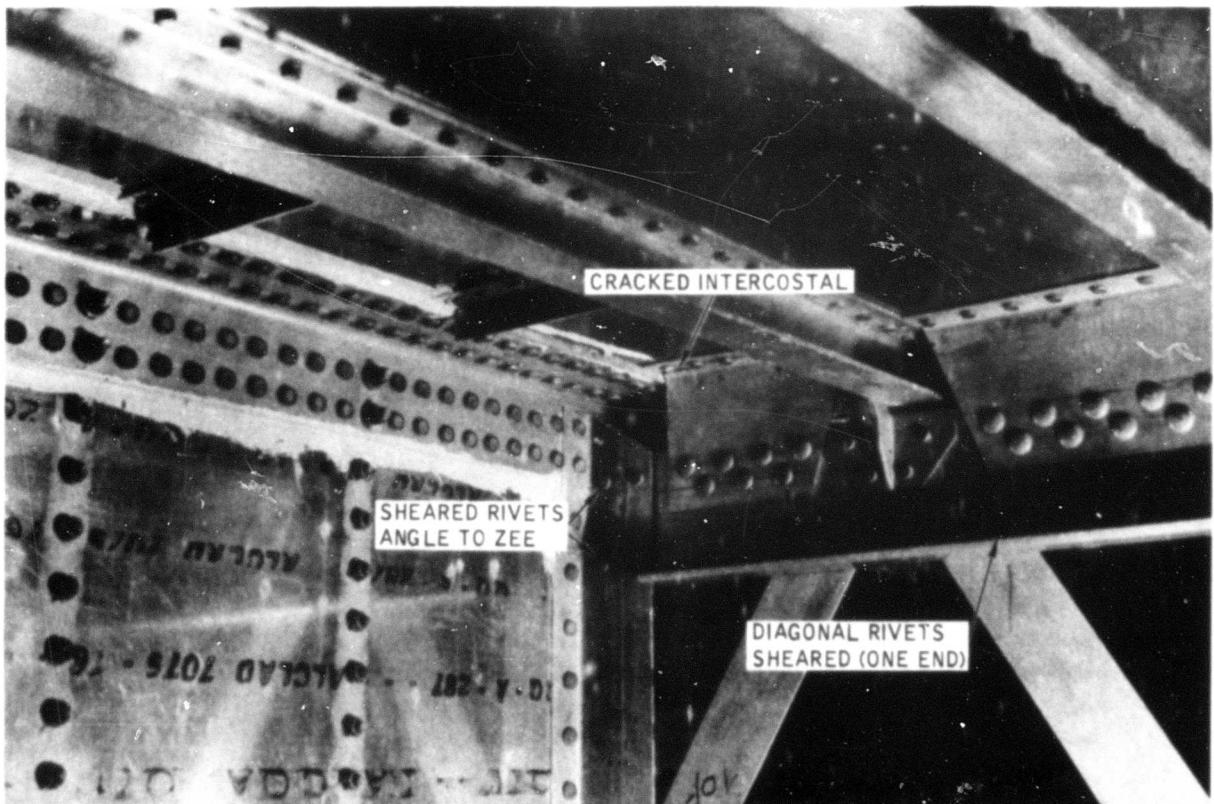
Figure B-19. Internal Failure of Test Tank No. 3.

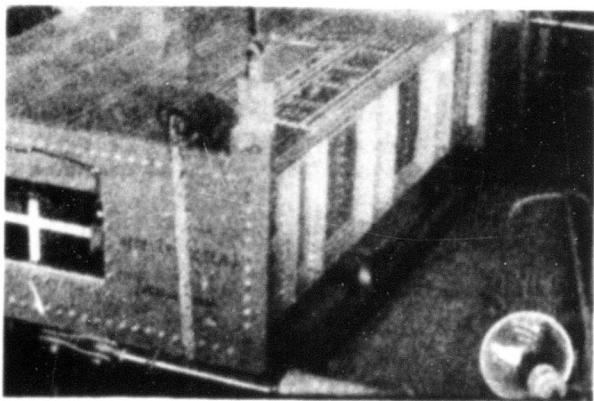
Figure B-20. External Damage to Test Tank No. 4. Tank was rebuilt from Tank No. 3. Steel rivets were added internally and skin doublers were added to the upper and lower surfaces (Figure B-24). Six rivets popped during Drop No. 18 — a 40-g arrested stop.

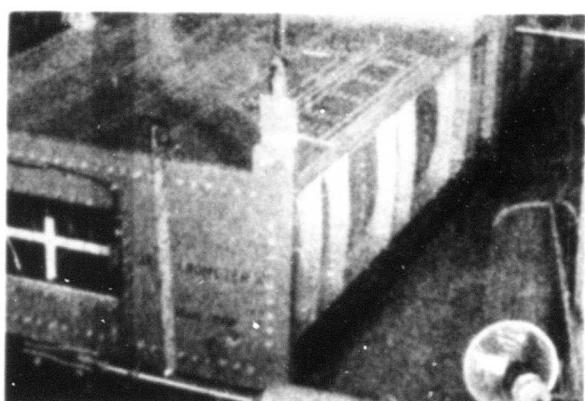
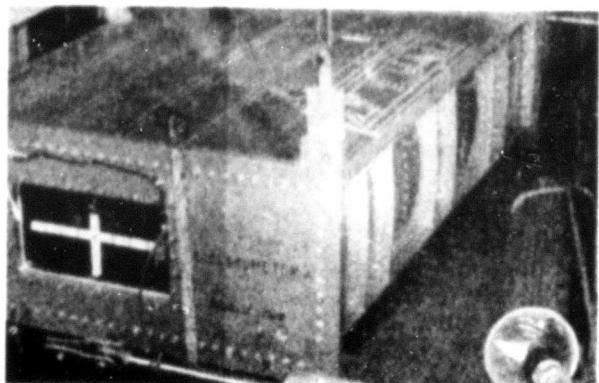
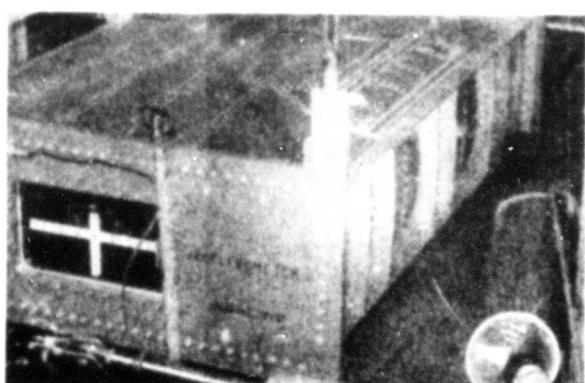
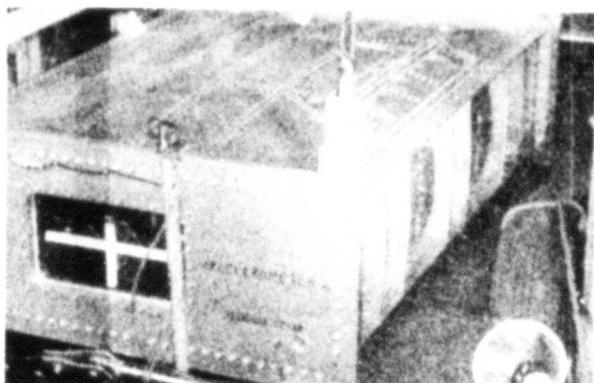
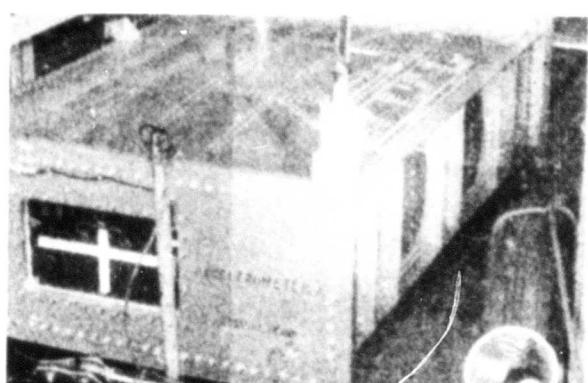
Figure B-21. Drop No. 18. 40-g arrested stop, Tank No. 4, impact velocity 48.4 fps, peak load 97,600 lb.

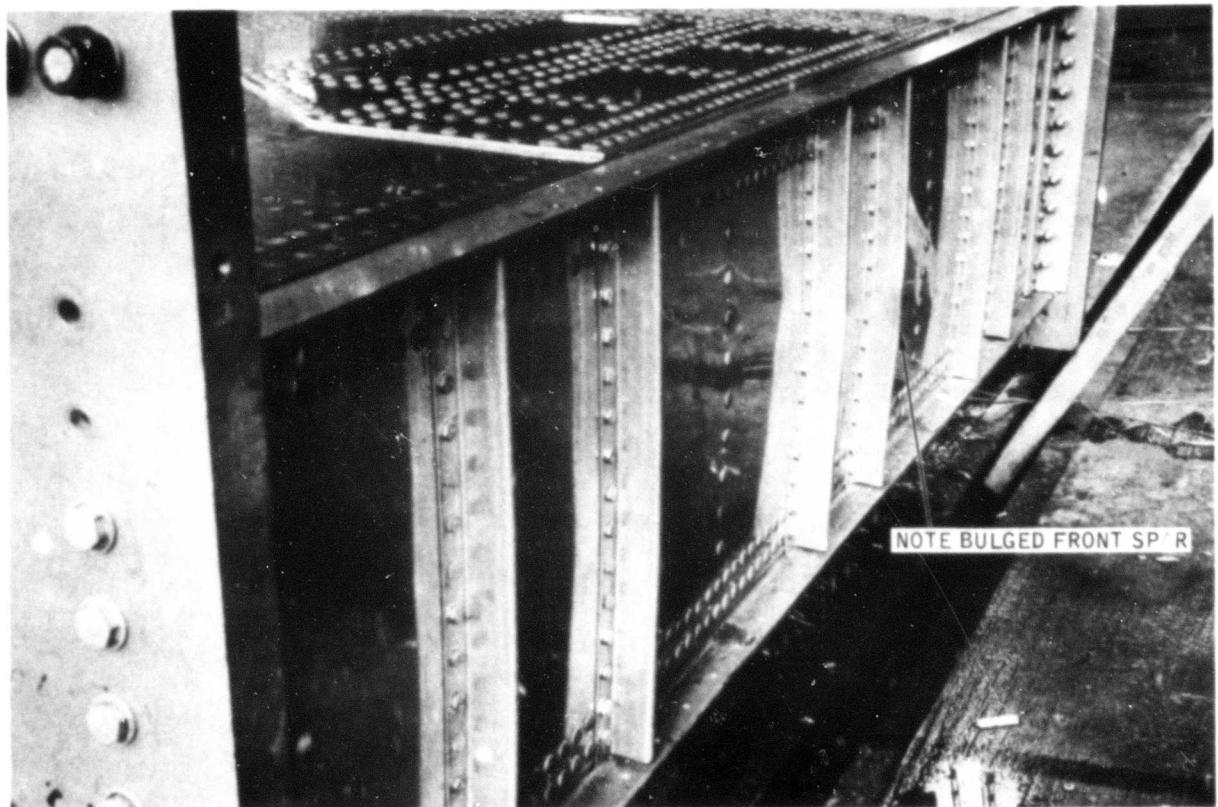
Figure B-22. Further External Damage to Tank No. 4. This shows bulge of front spar as a result of Drop No. 18 — a 40-g arrested stop. Only leakage was that shown in Figure B-20.

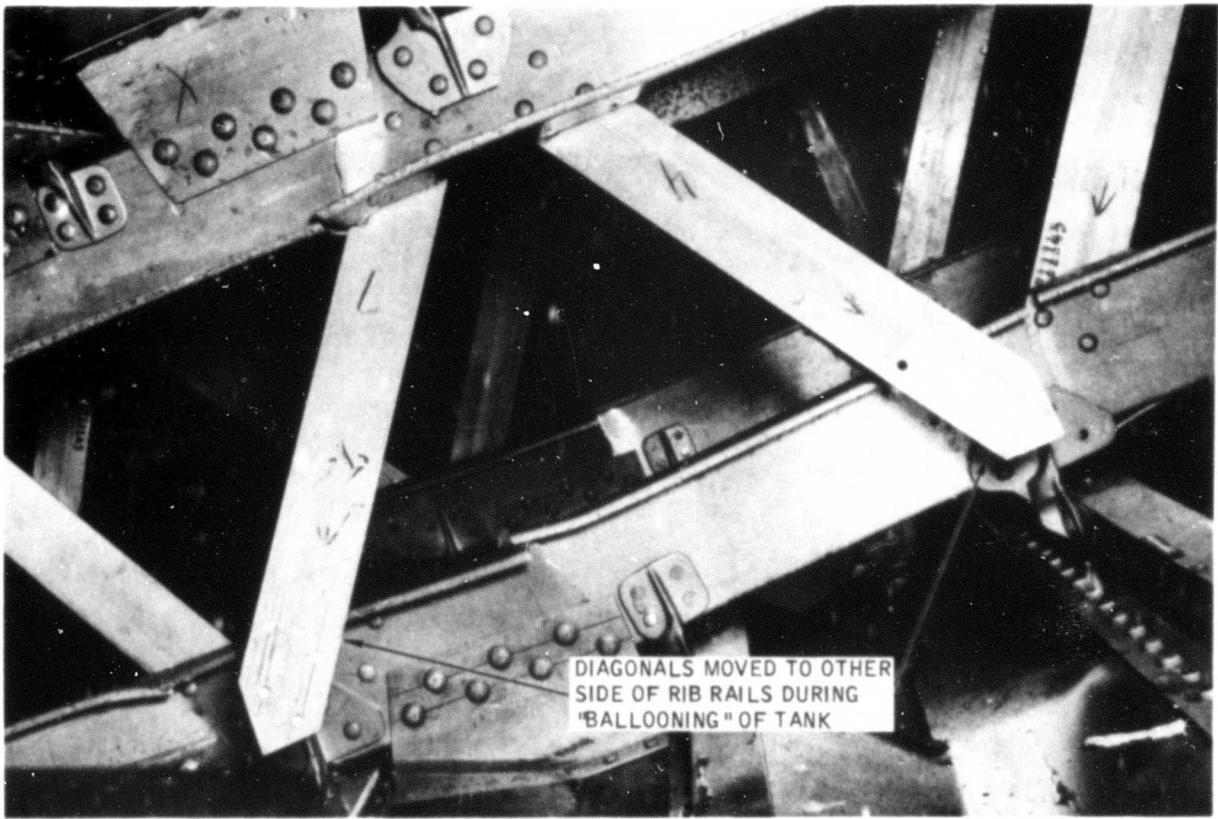
Figure B-23. Internal Damage to Tank No. 4. This shows further damage resulting from 40-g arrested stop. Note extreme deflections that must have occurred to allow two diagonals to switch from inboard to outboard side of rib rails.

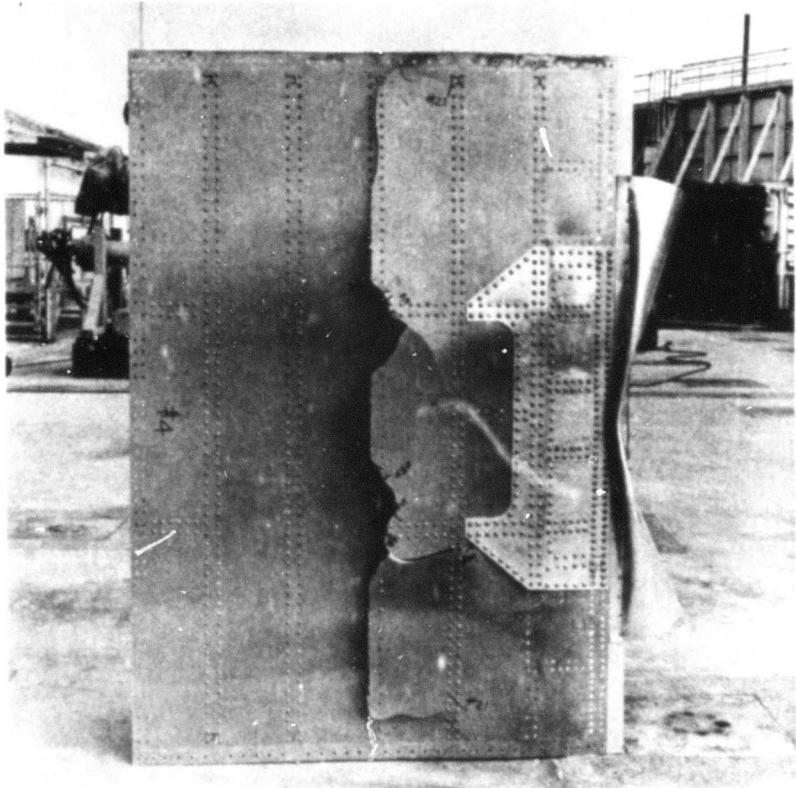
Figure B-24. Complete Failure of Test Tank No. 4. The six popped rivets shown in Figure B-20 were replaced and a log impact series of tests was begun. This shows progressive failure resulting from Drops 19, 20 and 21. Initial skin failure was 2-in. crack at an aft end of third-bay intercostal. Max. impact load was 94,100 lb.

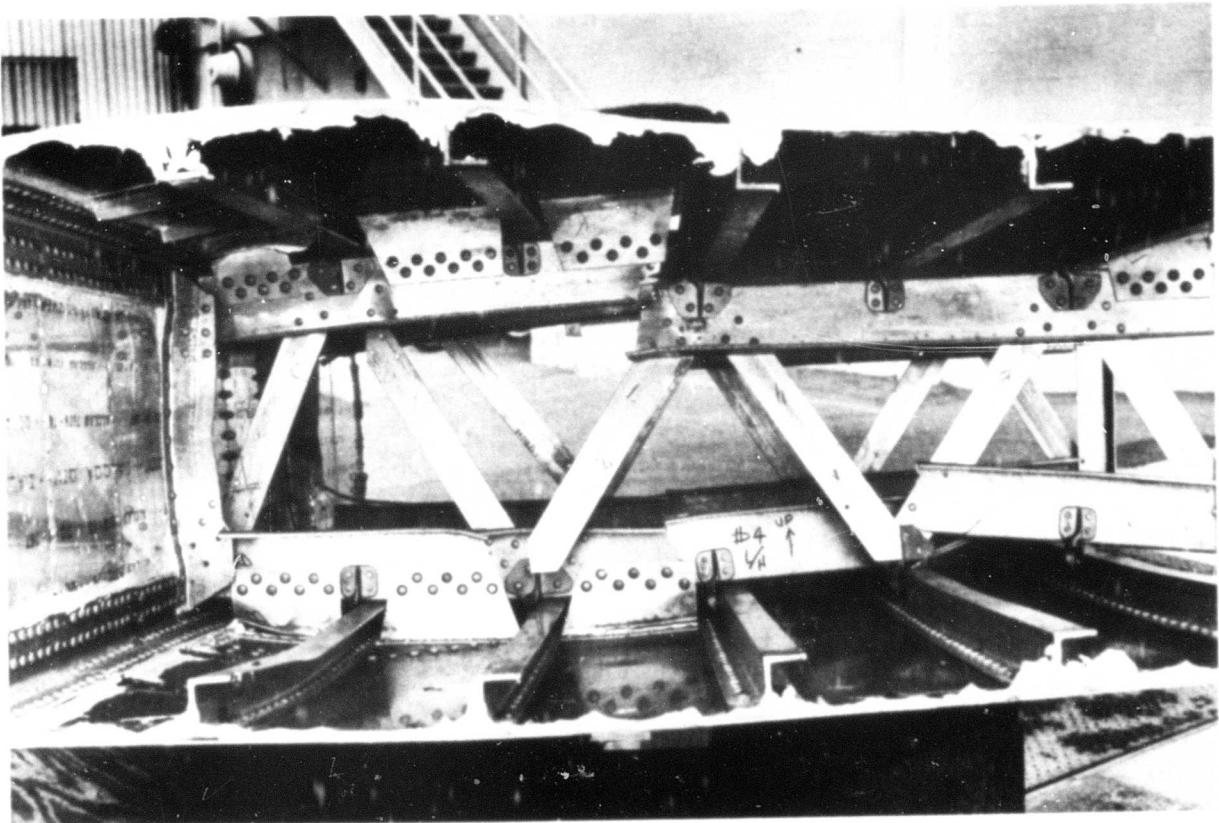
Figure B-25. Final Internal Damage to Tank No. 4

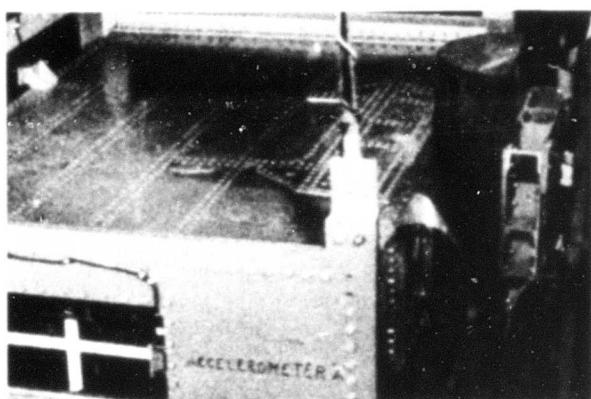
Figure B-26. Drop No. 19. Log impact, Tank No. 4, impact velocity 17.9 fps, peak load 70,200 lb.

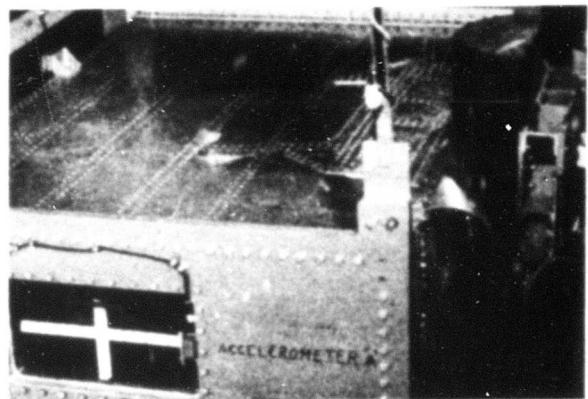
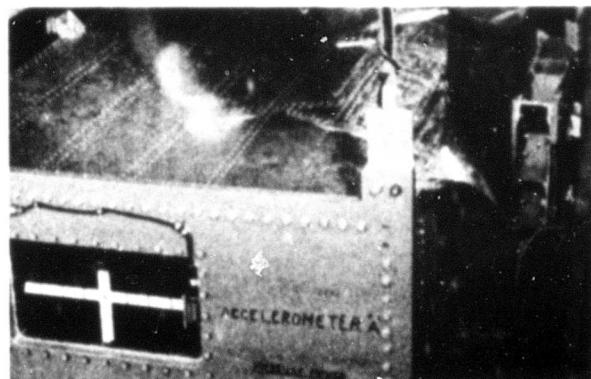
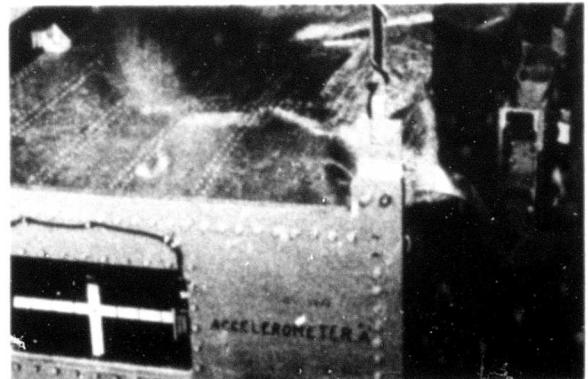
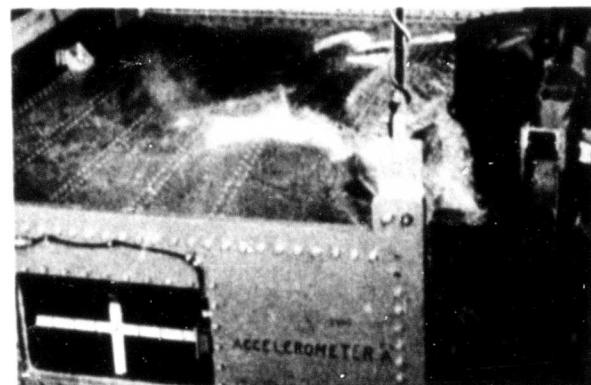
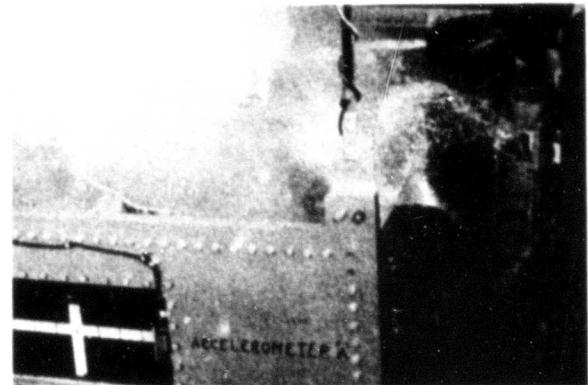
Figure B-27. Drop No. 21. Log impact, Tank No. 4, impact velocity 24 fps, peak load 94,100 lb.

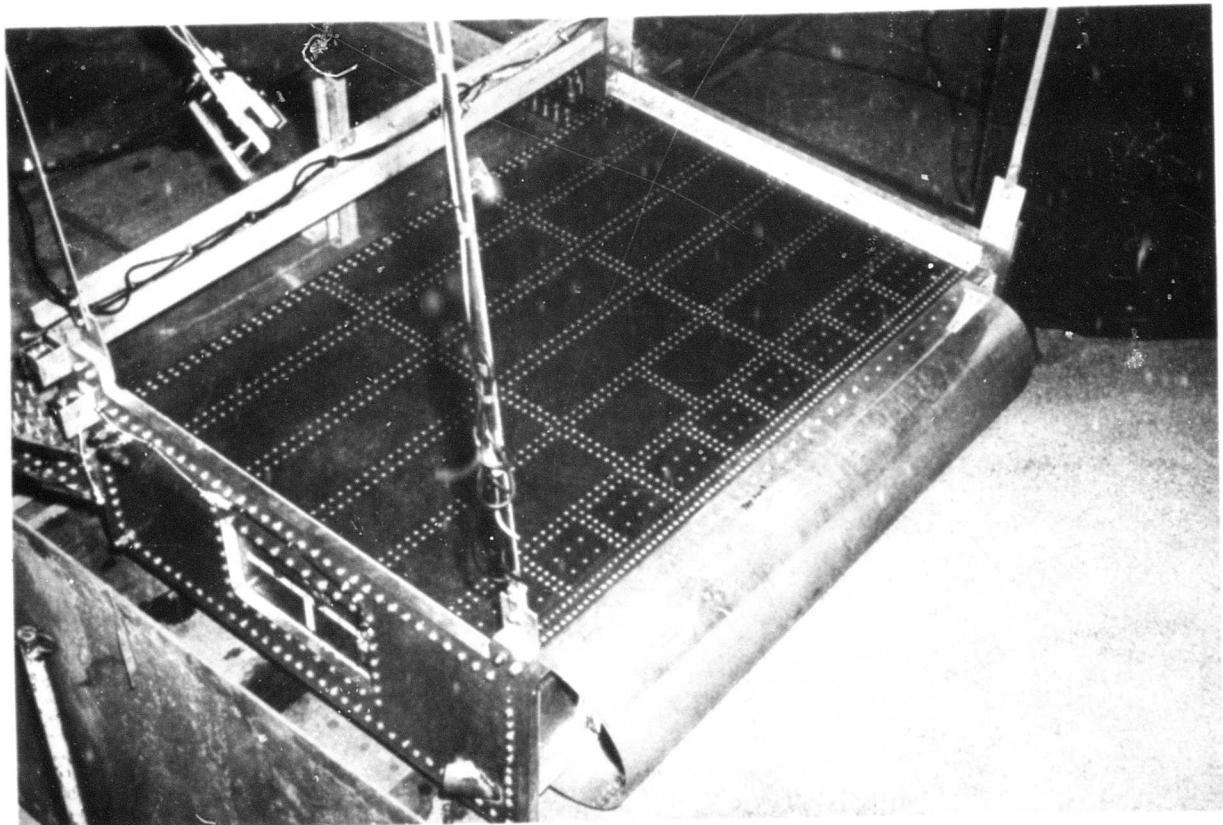
Figure B-28. Test Tank No. 6. Tests tanks 5 and 6 were identical and incorporated better features of previous tanks, plus web-type ribs.

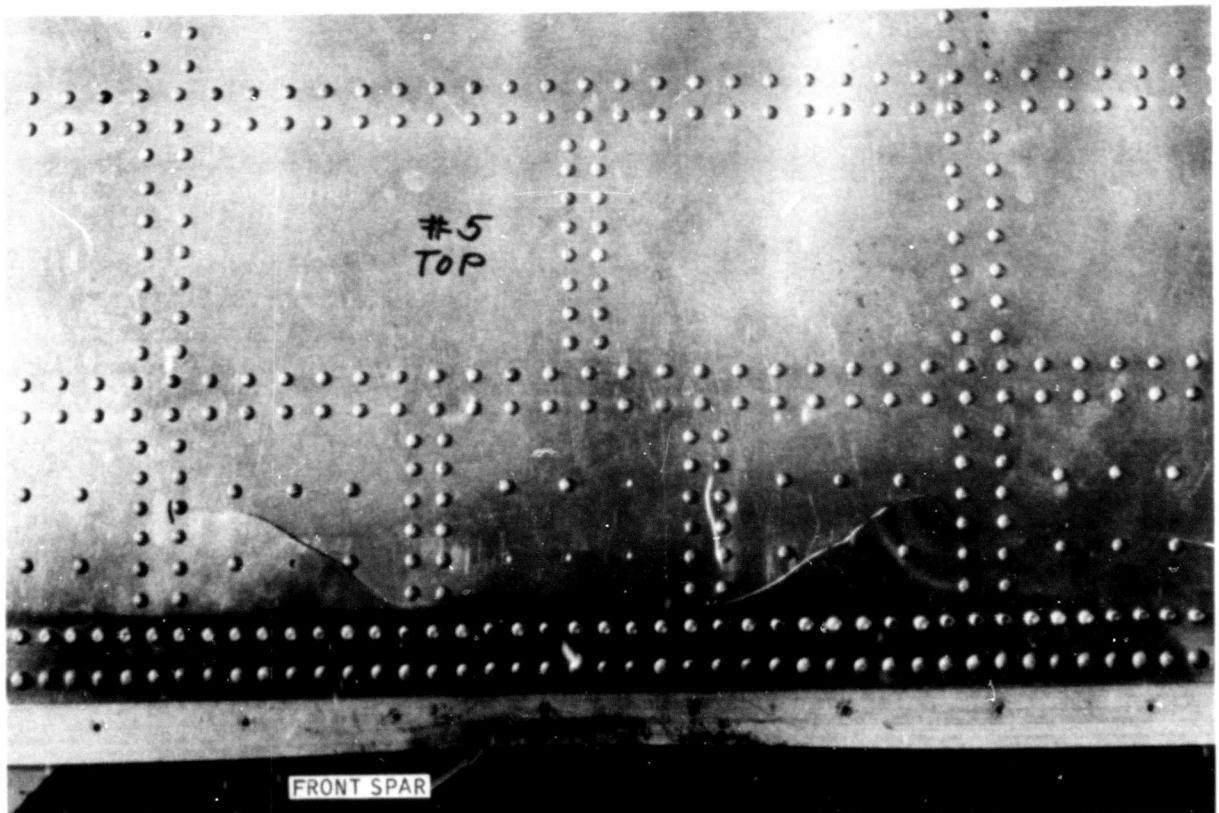
Figure B-30. Upper Skin Fracture, Tank No. 5. Result of Drop No. 25:
log impact test from drop height of 12 ft.; impact load was 97,000 lb.

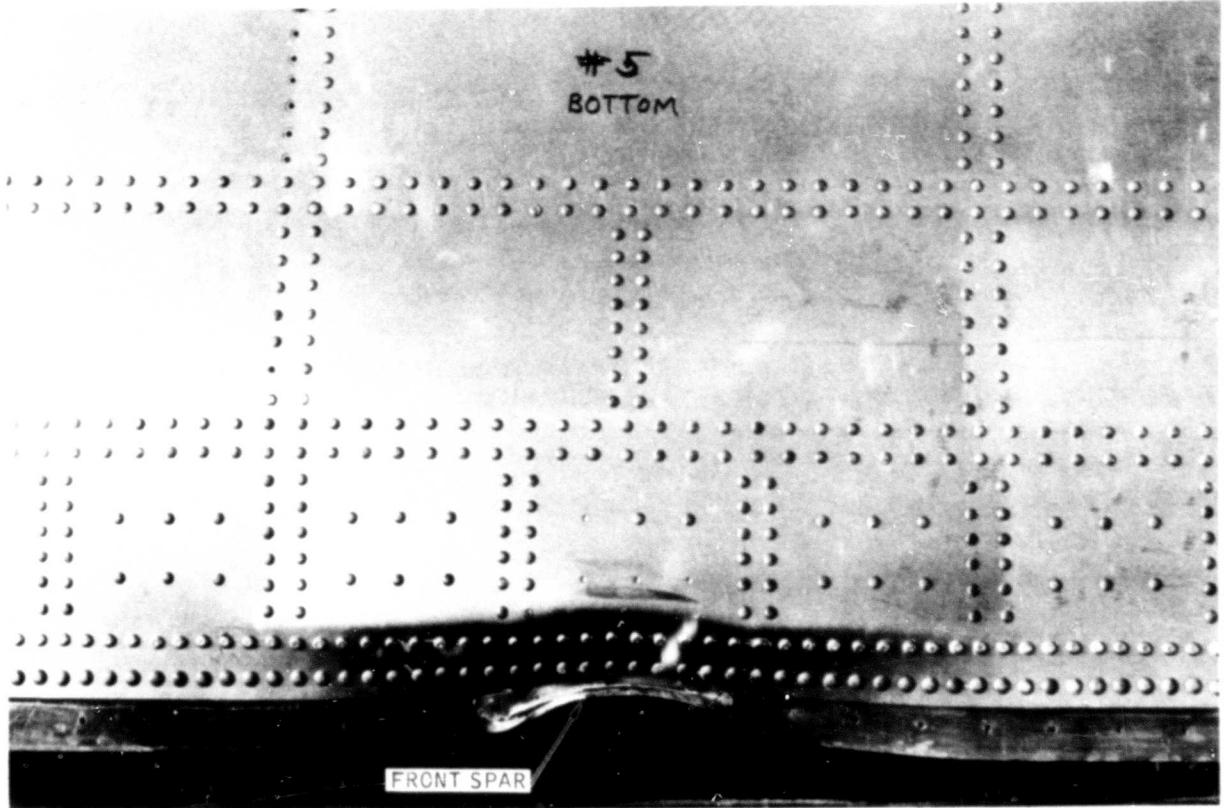
Figure B-31. Lower Surface of Tank No. 5. Results of Drop 25, impact load was 97,000 lb.
